**Objective:** to explain the meaning and to illustrate technical artifacts (aliasing as well as the ring artifact) and beam hardening (metal artifact) that can be present in the dentomaxillofacial cone beam computed tomography (CBCT), and to check the accessibility of free illustrations of these artifacts in medical publications.

**Keywords:** CBCT, artifact, beam hardening artifact, aliasing artifact, ring artifact

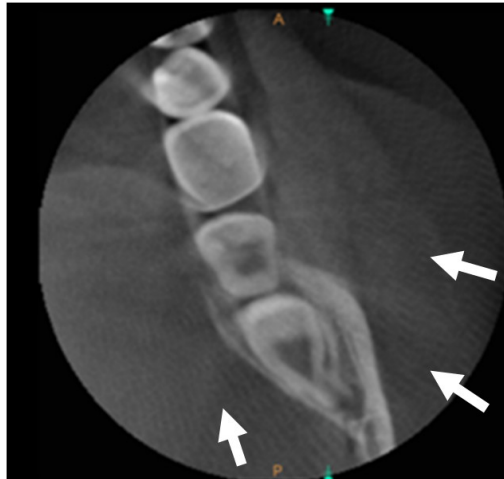
**Fig. 2. Carestream 9000 3D (Kodak).** Axial view of left mandible. Arrows: Aliasing artifact visible in soft tissues around the bone.

129 For each projection the voxels close to the source will be traversed by more  
 130 recorded "rays" than those close to the detector [2] because of the cone beam  
 131 divergence itself [2]. This causes aliasing which represents itself as line patterns  
 132 (moiré patterns), commonly diverging towards the periphery of the reconstructed  
 133 volume [2]. These patterns can decrease the quality of image. They can appear in  
 134 different types of dental CBCT (I-CAT, Carestream 9000 3D (Kodak)) (Figures 1,  
 135 2).  
 136  
 137

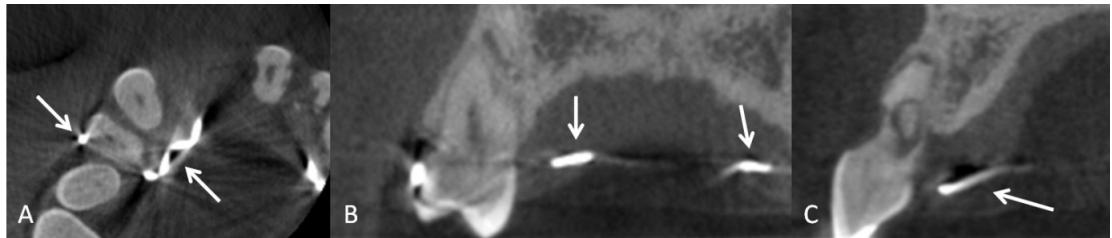
**Fig. 8. Carestream 9000 3D (Kodak).** Maxilla. A. Axial view. B. Frontal view. C. Sagittal view. Arrows showing hooks of removable partial prosthesis. Presence of streaks and black stripes due to beam hardening from metallic element.

171 detector (i.e. the beam is hardened), a non-linear error (relatively too much energy  
172 recorded in the beam path behind highly absorbing materials) is induced in the  
173 recorded data [3]. In the 3D reconstruction, the error is back projected into the  
174 volume, resulting in darks streaks.[4]. Because the CBCT X-ray beam is  
175 heterochromatic and has lower mean kilovolt (peak) energy compared with  
176 conventional CT, this artifact is more pronounced on CBCT images [3]. These can  
177 be reduced using iterative reconstruction [3]. Beam hardening artifact results in dark  
178 bands or streaks between dense objects in the image [3] (Figures 5, 8, 9, 10, 11, 14,  
179 15). This artifact is related to the presence of dental amalgam (Figures 4, 5), to  
180 crowns and bridges (Figure 6-8), and to dental implants (Figure 9).  
181

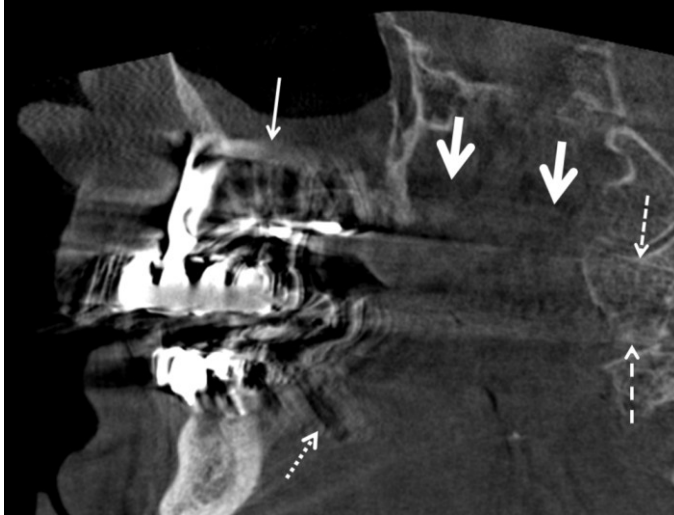
**Fig. 11. Planmeca Promax 3D Mid.** Sagittal view of maxilla and mandible. Thin arrow: superimposition of metallic artifact from subperiosteal implants on the floor of maxillary sinus. Thick arrows: metallic artifact from subperiosteal implants superimposed on nasopharyngeal space. Thin dashed arrows: metallic artifact from subperiosteal implants superimposed on cervical spine. Thin punctiform arrow: beam hardening from mandibular dental implant.

222 Especially, superiosteal implants [7] show massive beam hardening artifact  
223 making impossible the evaluation of adjacent soft and hard tissues (Figures 10-13).  
224

The importance of beam hardening artifact is related to the density of material and may vary from major perturbation of image with subperiosteal implants (Figures 10-13) to no perturbation with metallic orthodontic anchorage (Figures 44, 45). Beam hardening artifacts may vary according to the type and to the alloy material used in manufacturing of osteosynthesis screws. Screws used to fix orbit titanium plate (Figures 28, 29) shows less artifact than screws to fix titanium mesh on frontal bone (Figures 31-33). This may be of importance when checking if screws are not in

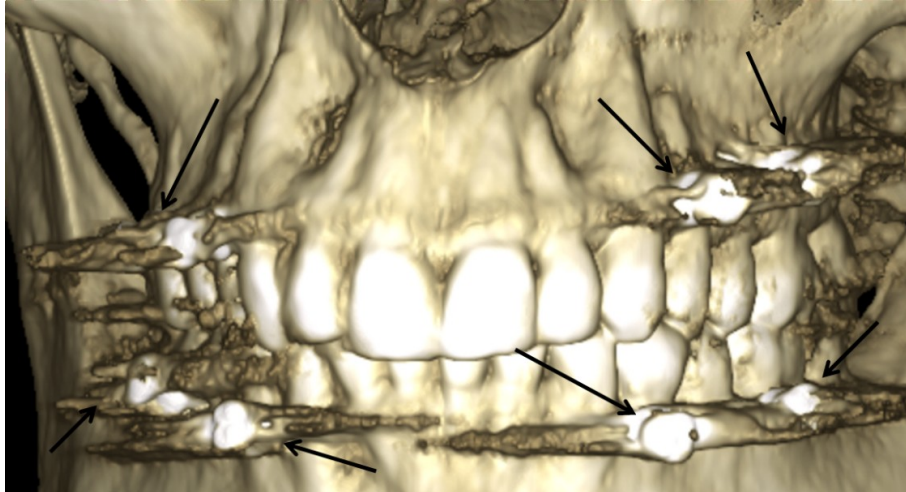
**Fig. 17. Planmeca Promax 3D Mid.** Anterior view of 3D reconstruction of maxilla and mandible. Black arrows: intermaxillary fixation screws presenting important beam hardening artifact.

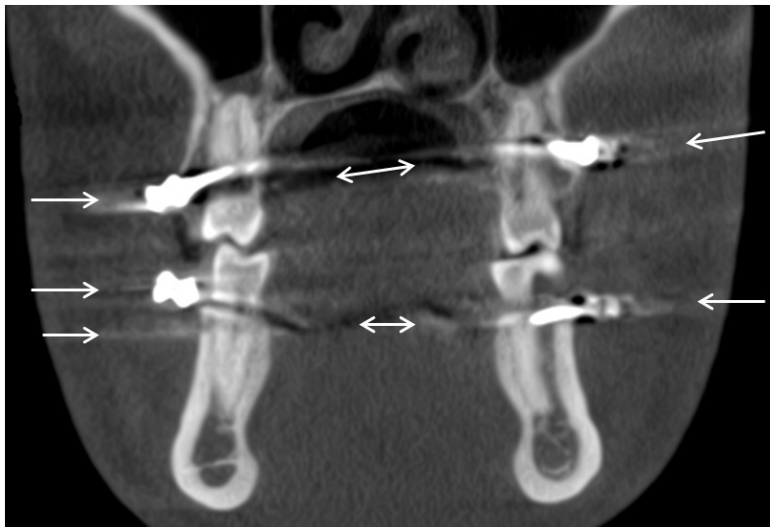
**Fig. 20. Planmeca Promax 3D Mid.** Frontal view of maxilla and mandible. Arrows: stripes in soft tissue around intermaxillary fixation screws due to beam hardening artifact. Double arrows: cumulation of black stripes from screws positioned at the same level on the right and the left side.

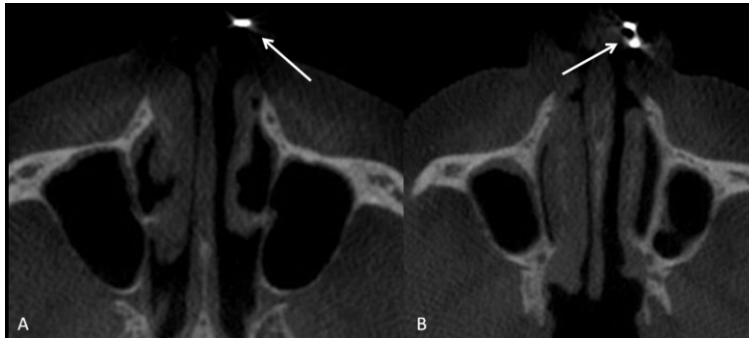
320  
321 **Fig. 21. I-CAT CBCT.** Axial view of maxilla. A. Arrow: piercing in left nostril  
322 wing with metallic beam hardening artifact. B. Arrow: ring of piercing in left  
323 nostril wing with metallic beam hardening artifact.  
324

314 Some metallic elements present in the field of view may show a beam hardening  
315 artifact, however this artifact will not disturb the evaluation of dentomaxillofacial  
316 structures. Nasal piercings (Figure 21), hearing aid devices (Figures 22, 23), and  
317 metallic clips on dreadlocks (Figures 24-27) give beam hardening artifacts with  
318 streaks present outside of the dentomaxillofacial area.  
319

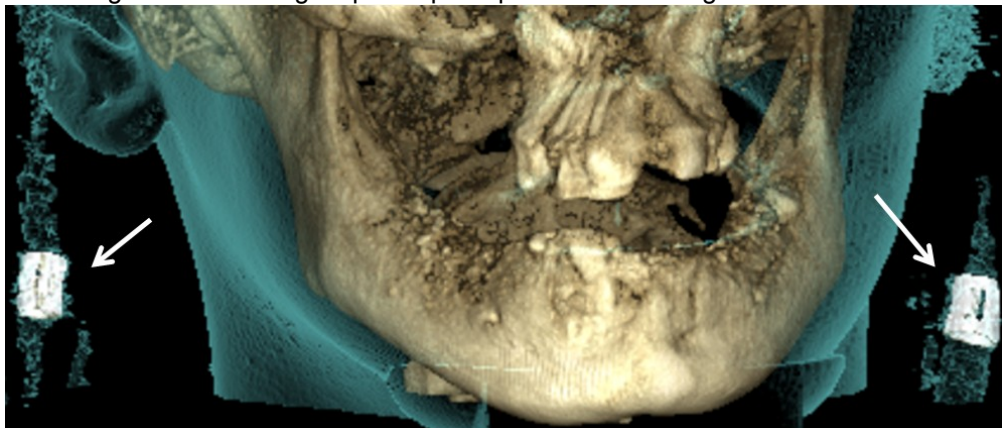
**Fig. 24. Planmeca Promax 3D Mid.** Frontal view of 3D reconstruction of mandible, maxilla, soft tissues, and hair (blue). Arrows: metallic clips on hair dreadlocks.

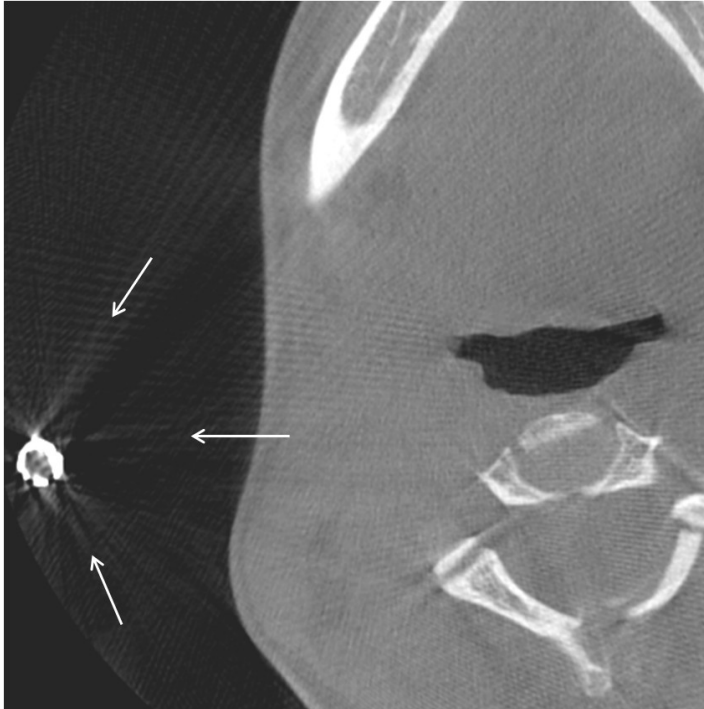
**Fig. 26. Planmeca Promax 3D Mid.** Axial view of right neck area. Arrows: beam hardening artifact from metallic clip on the dreadlock.

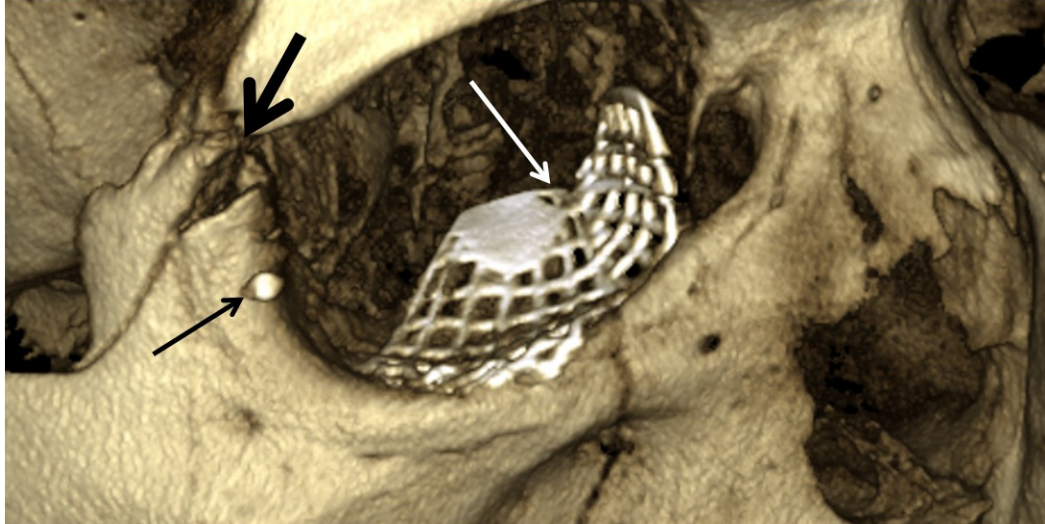
**Fig. 30. Planmeca Promax 3D mid.** Anterior and right lateral view of the 3D reconstruction of the right orbit. White arrow: prebended titanium mesh. Black thin arrow: subcutaneous dense foreign body without metallic artifact (plastic?). Black thick arrow: complex fracture at the right frontozygomatic junction.

Osteosynthesis titanium orbital plates present few beam hardening artifacts giving streaks around the plate (Figures 28-30). Osteosynthesis titanium mesh provides very few beam hardening artifacts that are visible only on 2D slices (Figures 32, 33) and not present on 3D reconstruction (Figure 31). However, screws securing titanium orbital plates (Figure 29) and mesh (Figure 33) show beam hardening artifacts with presence of streaks arising in all directions around the head of the screw (Figure 29) and along the long axis of the screw (Figure 33). Osteosynthesis plates show few beam hardening artifacts that are visible only on 2D slices (Figure 35) and not present on 3D reconstruction (Figure 34).

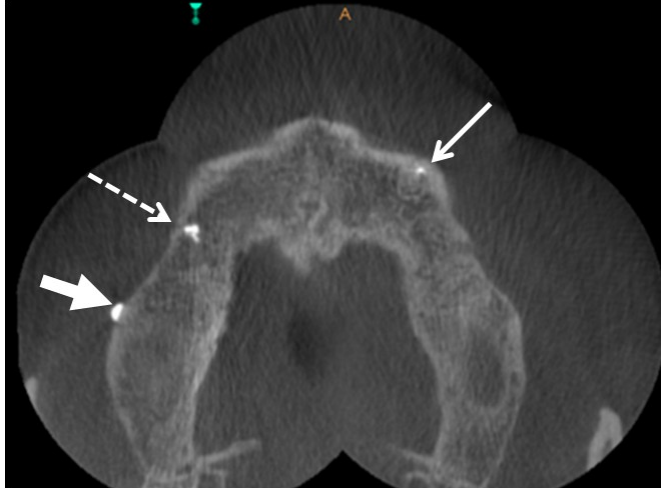
**Fig. 40. Carestream 9000 3D (Kodak).** Axial view of the maxilla; fusion of three fields of view. Thin arrow: root canal sealing with gutta-percha in tooth n°23. Dashed arrow: intraosseous endodontic material. Thick arrow: migration of endodontic material in subperiosteal space.

Some currently used dental elements such as composite fillings (Figure 37), endodontic filling with gutta-percha (Figures 38-40), prosthetic trays (Figure 41), orthodontic contention wire (Figure 42), pediatric crown (Figure 43), and orthodontic anchorage (Bollard type) and associated screws (Figures 44, 45) do not show beam hardening artifact.
